**PROPOSED UPGRADE OF TRANSNET HELIPAD AND  
ASSOCIATED INFRASTRUCTURE AT THE PORT OF RICHARDS  
BAY WITHIN UMHLATHUZE LOCAL MUNICIPALITY IN THE  
KWAZULU NATAL PROVINCE.**

**Prepared for Nsovo Environmental Consulting**

**Dr. J.M. Dabrowski**

**September 2022**

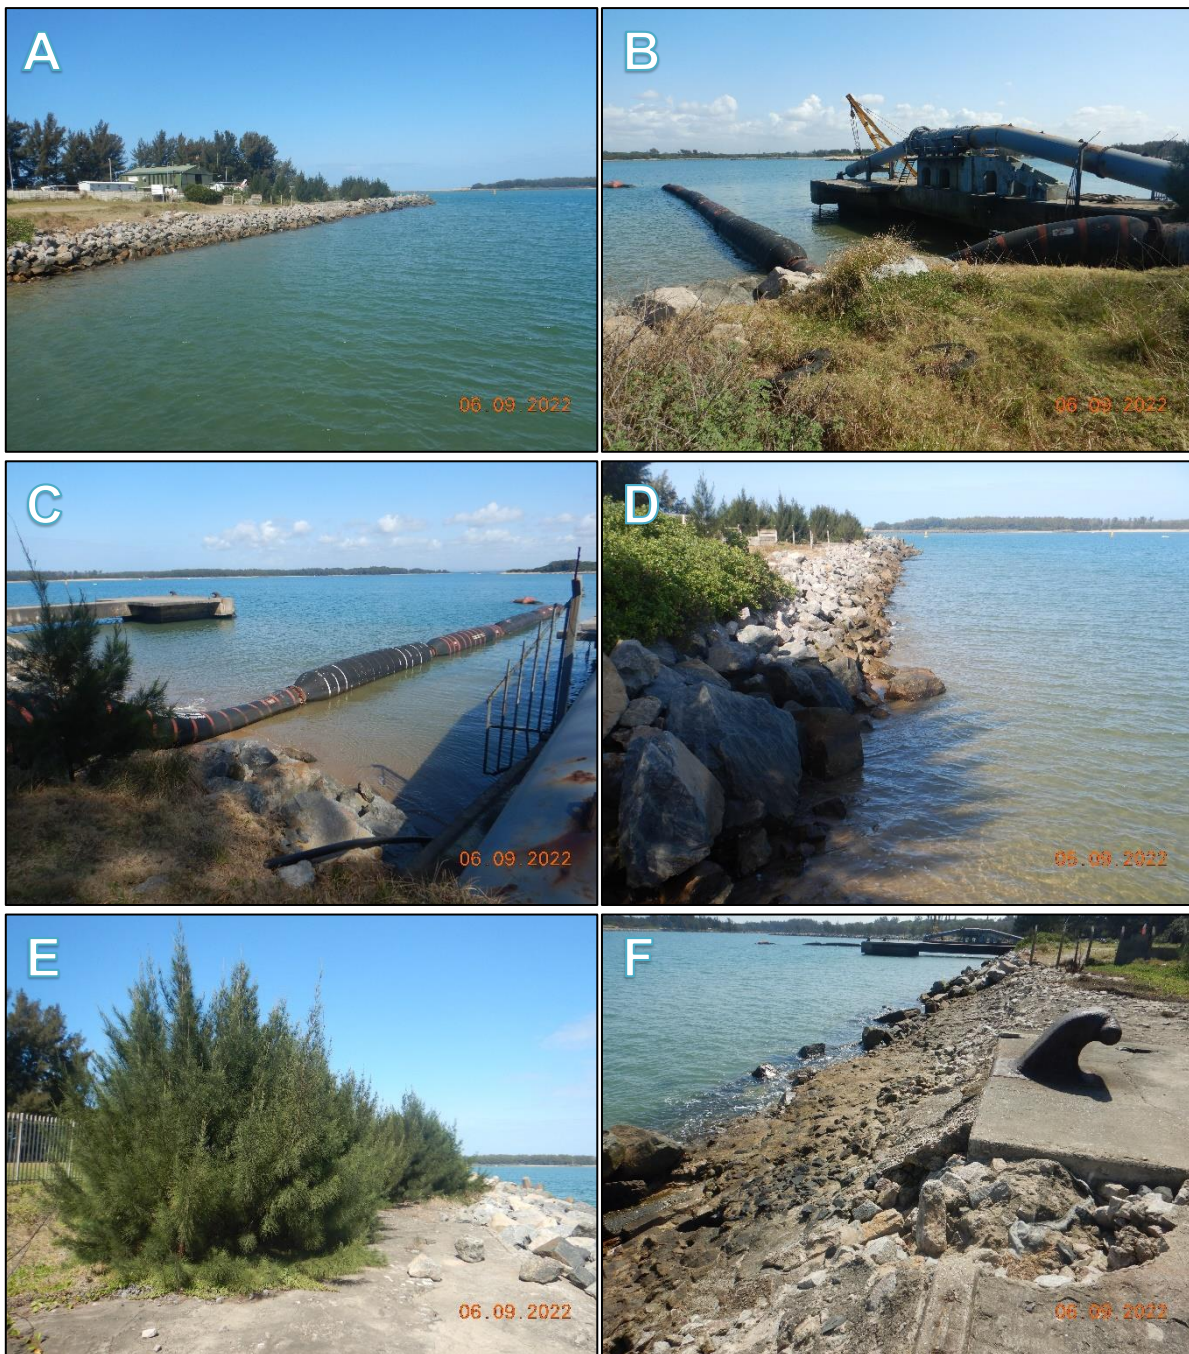
The site visit was conducted on the 6<sup>th</sup> of September, 2022. The estuarine shoreline along which the helipad is proposed to be constructed has been transformed through the placement of rock revetments and dolosse along the shoreline (Figure 9). It was evident that an initial sloped sea wall (constructed from stone and mortar) had failed in certain parts and had been covered by a more recent rock revetment solution. Former supratidal beach/dune habitat has been completely transformed by the existing helipad site and an informal unpaved parking area (to the north of the existing helipad) (Figure 10). There is a very narrow intertidal sandy beach section that is only exposed at low tide. The majority of available habitat is deeper, sandy open water with a soft, sandy substrate. There is no submerged or emergent estuarine vegetation present. A row of invasive *Casuarina cunninghamiana* run in between the existing helipad and the rock revetment. Two T-jetties are located to the north of the helipad site. The Transnet Ports Authority dredger moors near these jetties to pump spoil through pipelines housed on the jetties. This spoil is pumped onto the Alkanstrand Beach (to the east of the helipad site) to replenish sand that is routinely lost due to coastal erosion. A satellite image from the year 2020 shows the dredging ship moored just offshore from the jetties (Figure 11). It is also evident from this image that periodic sedimentation of the water column occurs during this process. The open water habitat adjacent to the proposed helipad is therefore relatively disturbed due to the frequent passage of the dredging ship and due to the actual dredging of the associated navigation channel (which lies approximately 7 m to the west of the outer edge of the helipad (for Option 1 and 3).

Figure 9: Photographs showing a view of the existing helipad and rock revetment from the estuary (A); T- jetties housing pipelines for pumping of spoil from the dredger (B) and (C); rock revetment along the shoreline (D), *Casuarina* trees along the line of the rock revetment (E) and a section of the collapsing sea wall that had been covered by rock armouring (F).

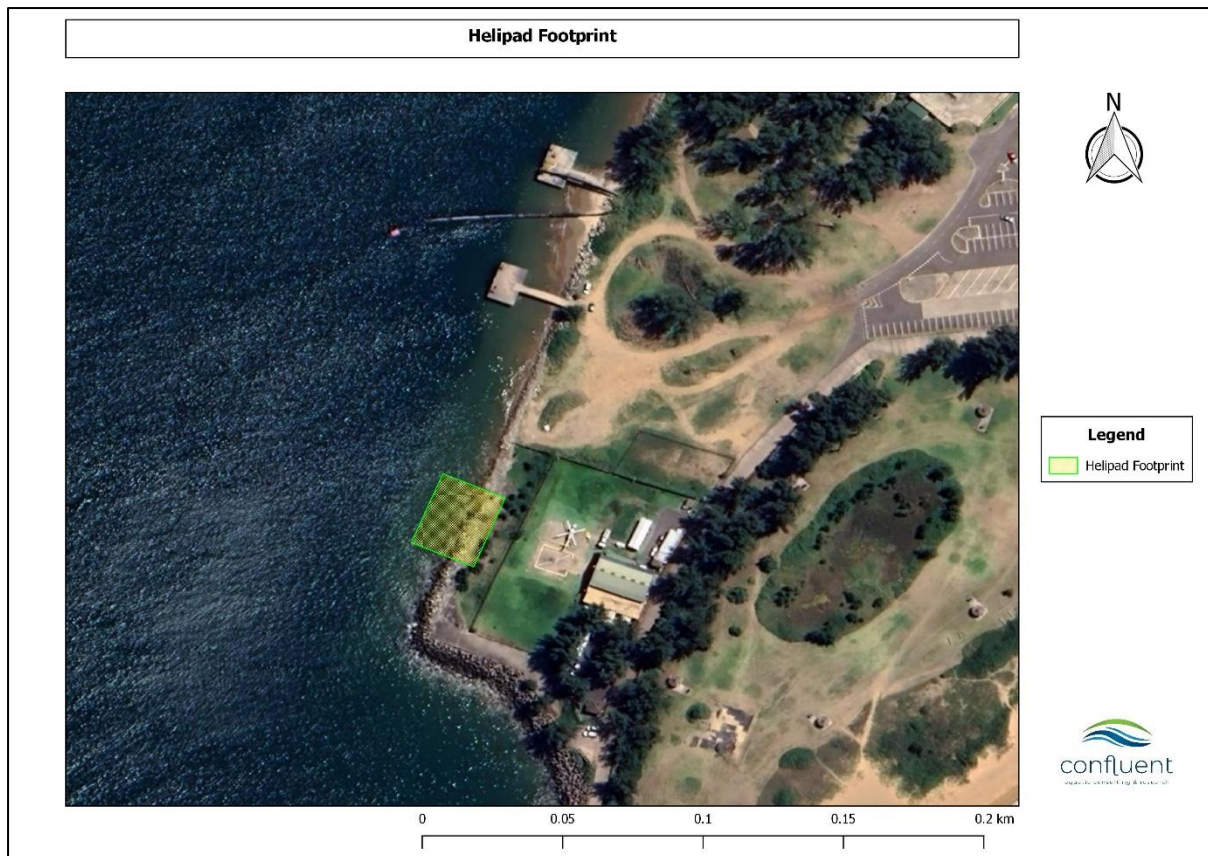
Figure 10: Map showing the approximate location of the proposed helipad relative to the existing helipad and associated buildings (to the east) and the informal parking area to the north. Note the two T-jetties located to the north where the dredger anchors and pumps spoil via pipelines onto the Alkanstrand.

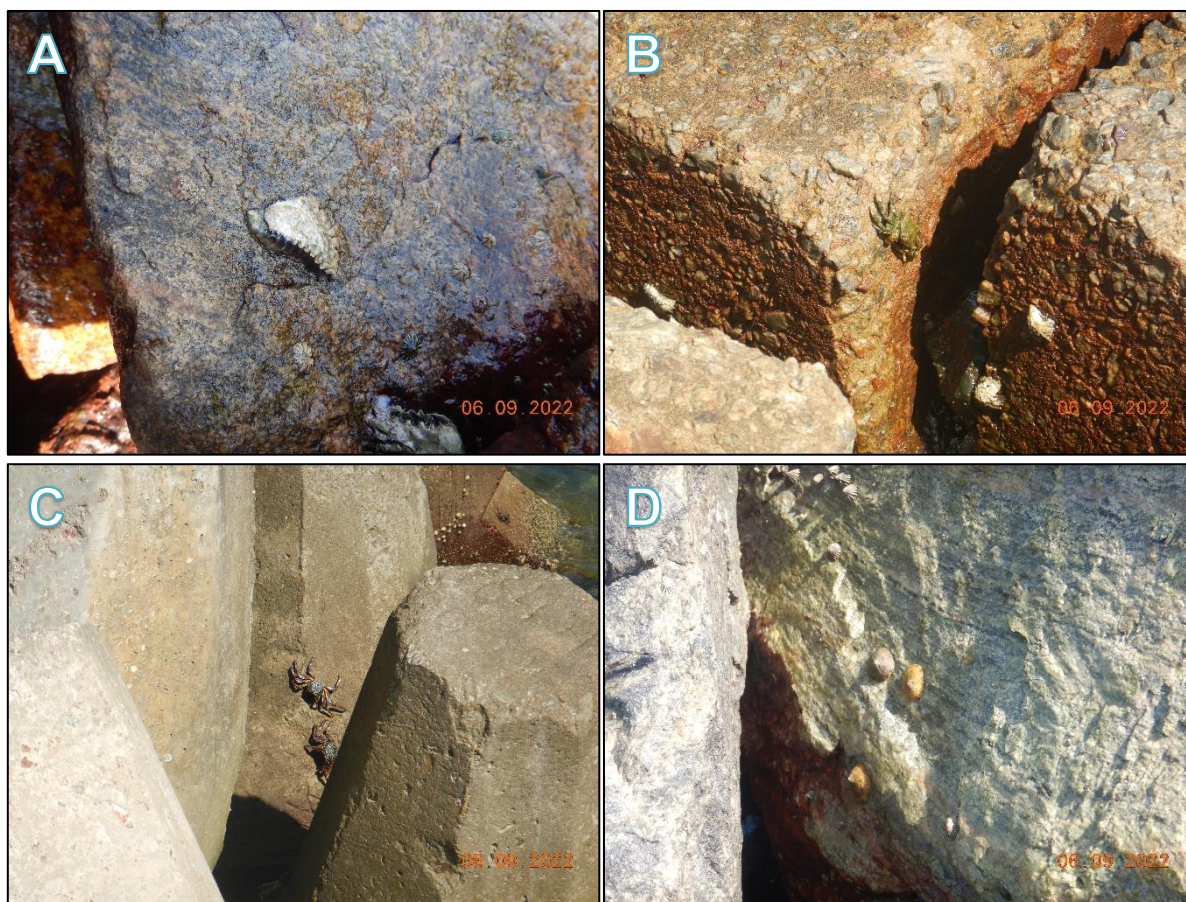
The rock revetment provided artificial habitat for a variety of biota, particularly the Natal Rock Crab (*Grapsus tenuicrustatus*), which were very abundant (Figure 12). Other fauna that were observed included the Green Rock Crab (*Grapsus fourmanoiri*) and molluscs typical of rocky inter-tidal zones, including Natal Rock Oyster (*Saccostrea cucullata*) and other periwinkle,

limpet and barnacle species. Burrows of mud prawn (*Callinassa kraussi*) were observed along the inter-tidal beach although these were not abundant. Numerous shoals of fish were observed utilising the rock revetment, presumably mainly for feeding, but also possibly for evasion of predators.

Figure 12: Photographs of biota observed on artificial rock habitat, including *Saccostrea cucullata* (Natal rock oyster) (A), *Grapsus fourmanoiri* (Green rock crab) (B), *Grapsus tenuicrustatus* (Natal rock crab) (C) and limpet species (D)
